Drainage Report

London

PRO-DRAIN LTD

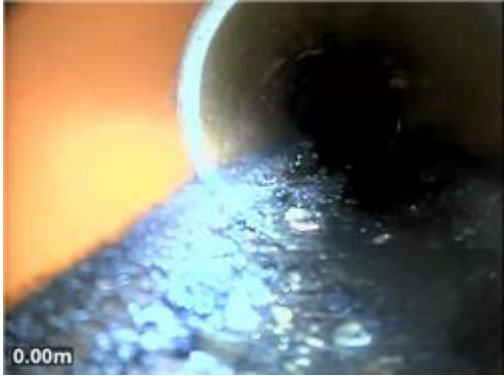
Pos	Video Ref	Code	Description	Image
00.00m		MH	Start node type, manhole MH1	
00.00m	0:00:00	WL	Water level: 0% Height/Diameter	
00.00m	0:00:04	S1 DEE	Attached deposits, encrustation 0m - 1.23m from 04 o'clock to 07 o'clock: 30% Cross sectional area loss - Severity 3 Scale build up	Image Provided - Ref: 0_2

<p>Section: 1 From: MH1 To: Sewer</p>	<p>Recommendation</p> <p>High pressure water jetting scale build up removal to restore the drains full working diameter</p> <p>Installation of a 2.98 meter 100mm resin impregnated drain lining to restore structural integrity to include the excavation and renewal of Gully 1 allowing for direct connection to manhole chamber 1 providing future access and the installation of an uncompromised continuous drain lining.</p>	<p>DRB Grade: B Pipe Size: 100 Material: Vitrified Clay (i.e. all clayware) Use: Combined</p>
<p>Section: 2 From: MH1 To: Grd Fir WC</p>	<p>Recommendation</p> <p>High pressure water jetting scale build up removal to restore the drains full working diameter</p>	<p>DRB Grade: B Pipe Size: 100 Material: Polyvinyl Chloride Use: Combined</p>
<p>Section: 3 From: MH1 Branch 1 To: SVP</p>	<p>Recommendation</p> <p>High pressure water jetting encrustation removal to restore the drains full working diameter</p> <p>Installation of a 1.10 meter 100mm resin impregnated drain lining to restore structural integrity</p>	<p>DRB Grade: B Pipe Size: 100 Material: Cast Iron Use: Combined</p>

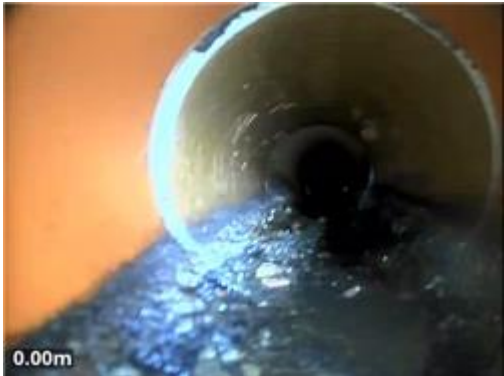
0.00m
00.11m	0:00:10	JDM	Joint displaced medium - Severity 3	Image Provided - Ref: 0_3

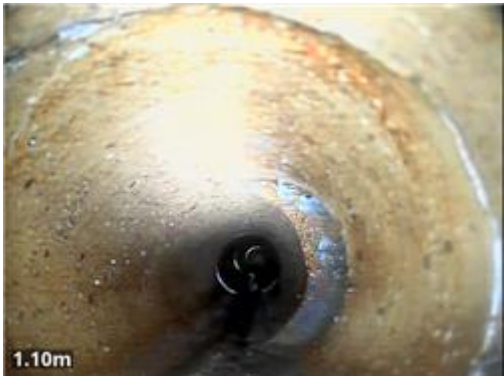
0.00m
01.20m	0:00:16	CCJ	Crack, circumferential from 09 o'clock to 02 o'clock at joint - Severity 1	Image Provided - Ref: 0_6

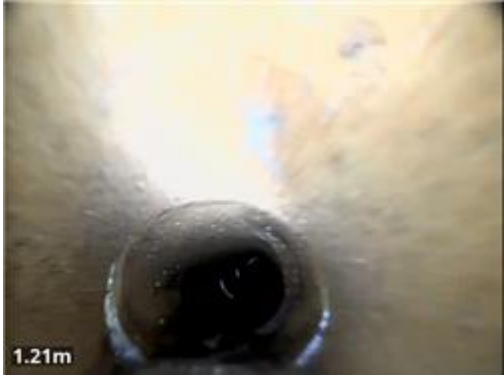
Pos	Video Ref	Code	Description	Image
01.22m	0:00:15	JDM	Joint displaced medium - Severity 3	Image Provided - Ref: 0_4

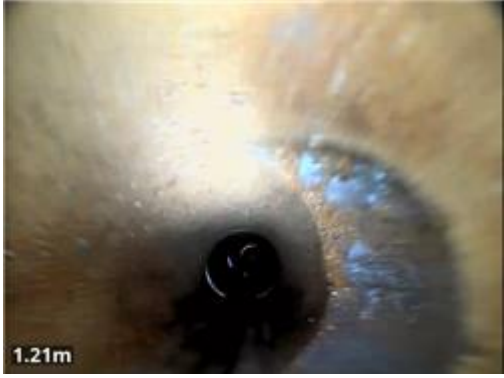
01.23m	0:00:16	JN	Junction at 03 o'clock: 100mm Diameter Serves Gully 1	Image Provided - Ref: 0_5

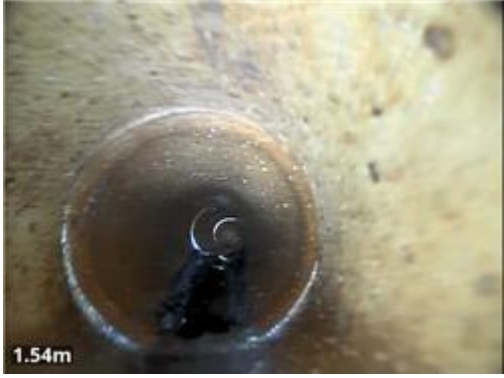
01.54m	0:00:35	JDM	Joint displaced medium - Severity 3	Image Provided - Ref: 0_7

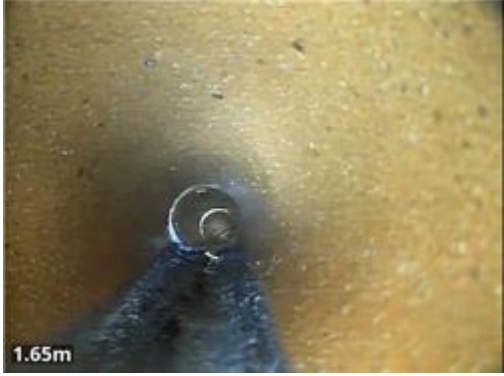
01.65m	0:00:36	DEE	Attached deposits, encrustation from 05 o'clock to 07 o'clock: 10% Cross sectional area loss - Severity 3 Scale build up	Image Provided - Ref: 0_8

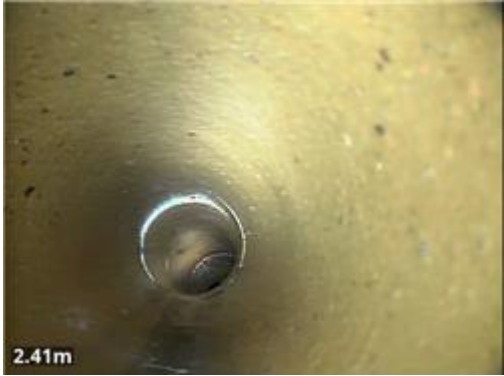
Pos	Video Ref	Code	Description	Image
02.41m	0:00:48	REM	General remark Property Boundary - Beyond this point the drain is owned by and the responsibility of the local water authorities as per the private lateral drain transfer bill 2011	Image Provided - Ref: 0_9

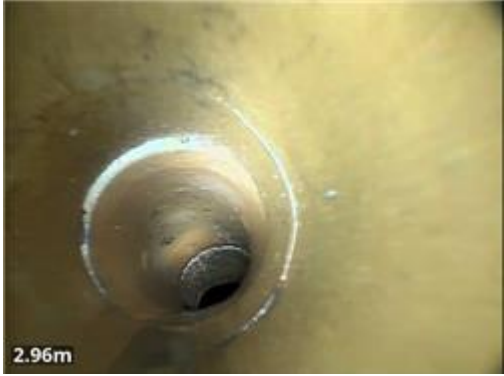
02.96m	0:00:49	FC	Fracture circumferential from 12 o'clock to 06 o'clock - Severity 3	Image Provided - Ref: 0_10

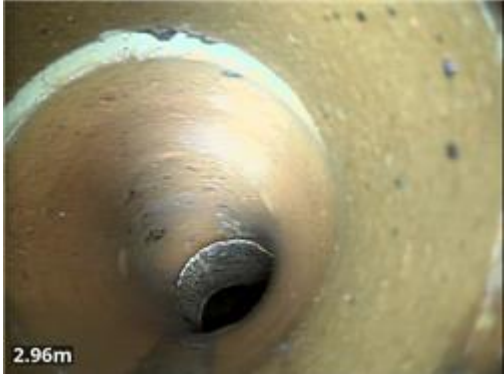
02.97m	0:00:50	JDM	Joint displaced medium - Severity 3	Image Provided - Ref: 0_11

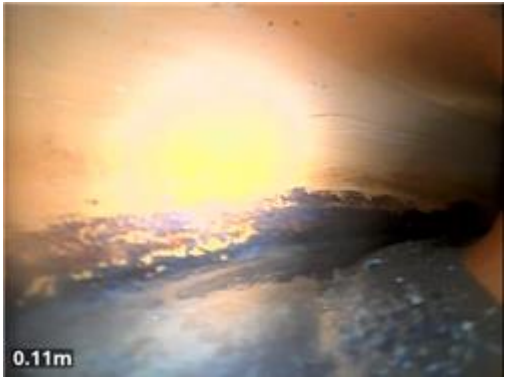
0.00m
00.11m	0:00:07	LRF	Line of drain/sewer deviates right [full]	Image Provided - Ref: 1_3

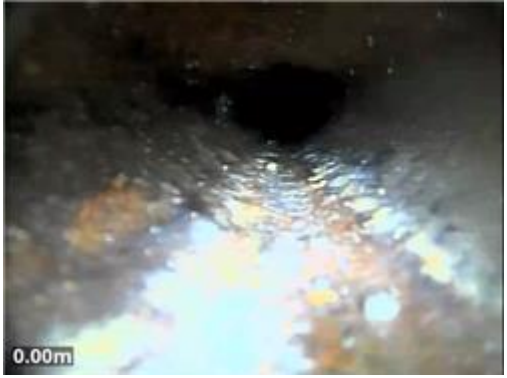
Pos	Video Ref	Code	Description	Image
00.00m		MH	Start node type, manhole MH1 Branch 1	
00.00m	0:00:00	WL	Water level: 0% Height/Diameter	
00.00m	0:00:06	S1 DEE	Attached deposits, encrustation 0m - 1m from 12 o'clock to 12 o'clock: 10% Cross sectional area loss - Severity 3	Image Provided - Ref: 2_2

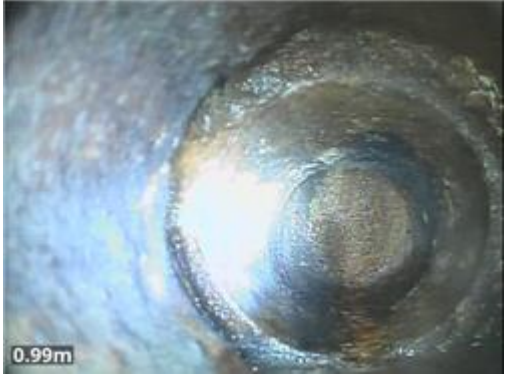
01.00m	0:00:10	OJM	Open joint medium - Severity 3	Image Provided - Ref: 2_3

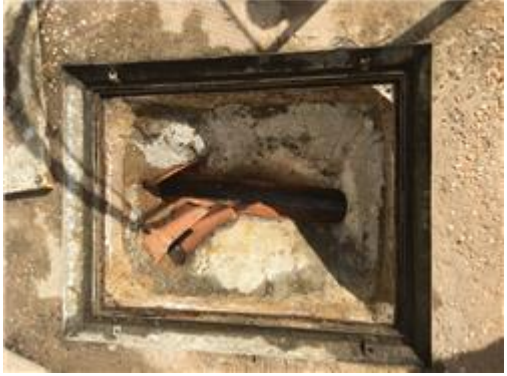
00.00m	0:00:00	WL	Water level: 0% Height/Diameter	
00.00m	0:00:11	REM	General remark There is no interceptor trap to stop rodent or odour infiltration into the private drainage system from the local authorities sewer	
00.10m		MHF	Finish node type, manhole MH1

<p>Section: 4 From: MH1 Branch 2 To: Gully 2</p>	<p>Recommendation</p> <p>N/A</p>	<p>DRB Grade: A Pipe Size: 100 Material: Polyvinyl Chloride Use: Combined</p>
<p>Section: 5 From: MH1 To: MH1</p>	<p>Recommendation</p> <p>Installation of a non return valve unit to prevent rodents and odours from the local authorities sewer</p>	<p>DRB Grade: A Pipe Size: 450 Material: Brick Use: Combined</p>
