Drainage Report

**East Lane Business Park
 Wembley**

**32 Westwood Park Industrial Estate
 Park Royal
 London
 W3 0TH**

32 Westwood Park - CCTV Survey Report : 19-03-24

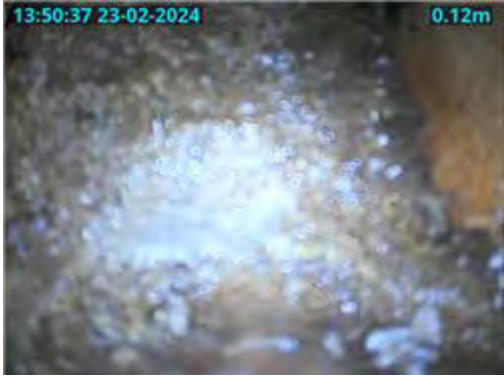
Pos	Video Ref	Code	Description	Image
00.12m	0:00:07	DEE	Attached deposits, encrustation from 03 o'clock to 09 o'clock: 20% Cross sectional area loss - Severity 3 Scale build up	Image Provided - Ref: 3_4

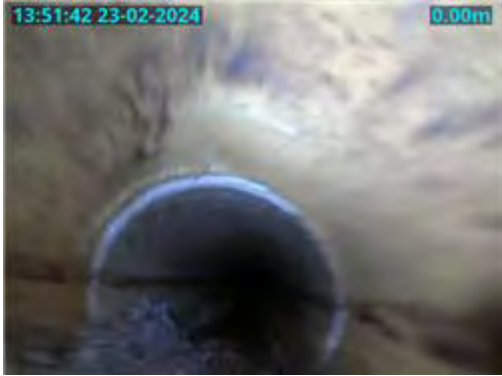
00.20m	0:00:10	S1 DEE	Attached deposits, encrustation 0.2m - 5.33m from 05 o'clock to 09 o'clock: 20% Cross sectional area loss - Severity 3 Scale build up	Image Provided - Ref: 4_3

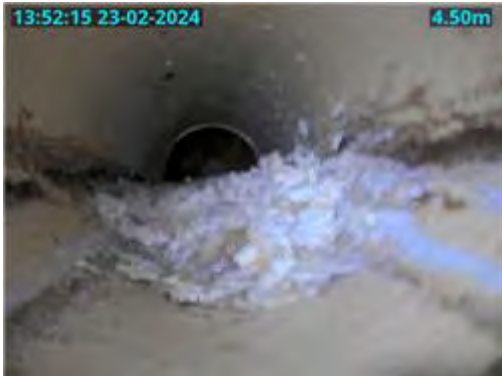
Pos	Video Ref	Code	Description	Image
04.50m	0:00:43	C1 DEE	Attached deposits, encrustation from 03 o'clock to 09 o'clock: 50% Cross sectional area loss - Severity 3	Image Provided - Ref: 4_4

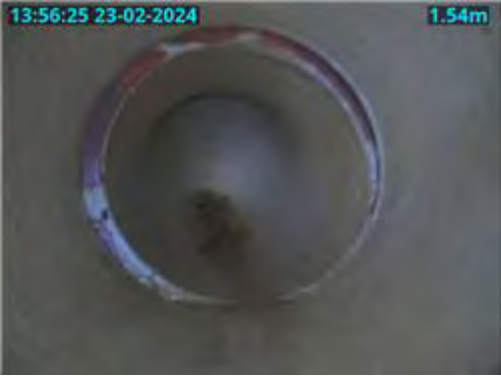
01.54m	0:00:25	OJM	Open joint medium - Severity 3	Image Provided - Ref: 8_3

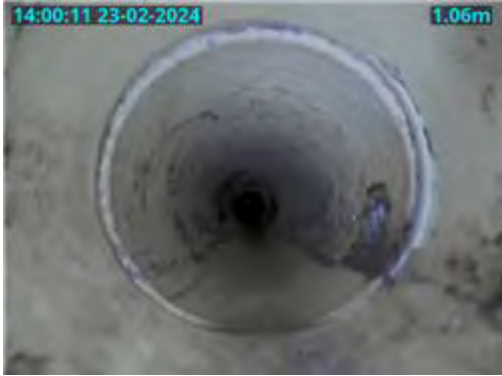
01.06m	0:00:14	CCJ	Crack, circumferential from 02 o'clock to 05 o'clock at joint - Severity 1	Image Provided - Ref: 10_3

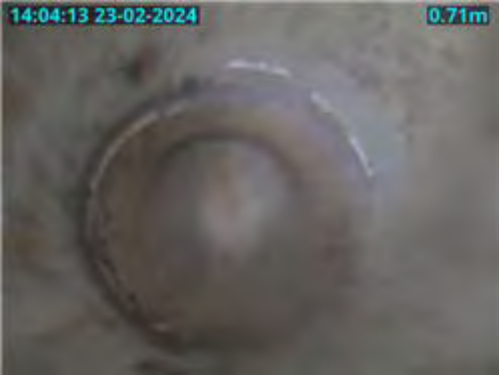
00.70m	0:00:05	CCJ	Crack, circumferential from 12 o'clock to 03 o'clock at joint - Severity 1	Image Provided - Ref: 11_2

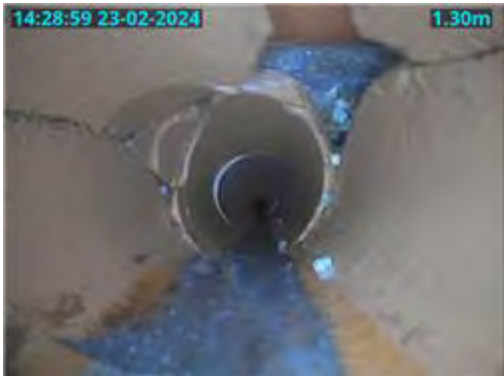
00.80m	0:00:09	B	Broken pipe from 12 o'clock to 12 o'clock - Severity 4	
01.30m	0:00:20	H	Hole in drain/sewer from 12 o'clock to 03 o'clock - Severity 4	Image Provided - Ref: 13_4

<p>Section: 14 From: FWMH1 To: Sewer</p> <p>MH</p>	<p>Recommendations</p> <p>Urgent installation of a 15 meter 100mm resin impregnated drain lining.</p> <p>Investigation to locate the end node of this drain run and CCTV monitored high pressure water jetting settled deposit removal.</p>	<p>DRB Grade: C Pipe Size: 100 Material: Vitrified Clay (i.e. all clayware) Use: Foul</p>
<p>Section: 15 From: RWP1 To: Jct RWP2</p> <p>OC</p>	<p>Recommendations</p> <p>N/A</p>	<p>DRB Grade: A Pipe Size: 100 Material: Pitch fibre Use: Surface Water</p>
<p>Section: 16 From: RWP2 To: Jct RWP3</p> <p>OC</p>	<p>Recommendations</p> <p>N/A</p>	<p>DRB Grade: A Pipe Size: 100 Material: Pitch fibre Use: Surface Water</p>
<p>Section: 17 From: RWP3 To: SWMH1</p> <p>OC</p>	<p>Recommendations</p> <p>N/A</p>	<p>DRB Grade: A Pipe Size: 100 Material: Pitch fibre Use: Surface Water</p>
<p>Section: 18 From: SWMH1 B1 To: SWG</p> <p>MH</p>	<p>Recommendations</p> <p>N/A</p>	<p>DRB Grade: A Pipe Size: 100 Material: Pitch fibre Use: Surface Water</p>

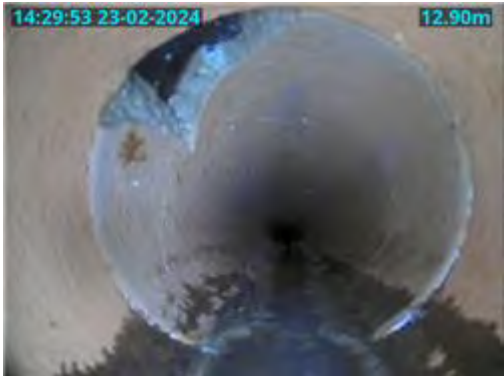
12.90m	0:01:08	H	Hole in drain/sewer from 10 o'clock to 12 o'clock - Severity 4	Image Provided - Ref: 13_5

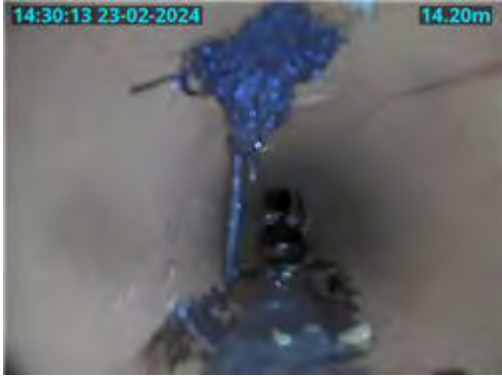
Pos	Video Ref	Code	Description	Image
14.20m	0:01:21	H	Hole in drain/sewer from 11 o'clock to 01 o'clock - Severity 4	Image Provided - Ref: 13_7

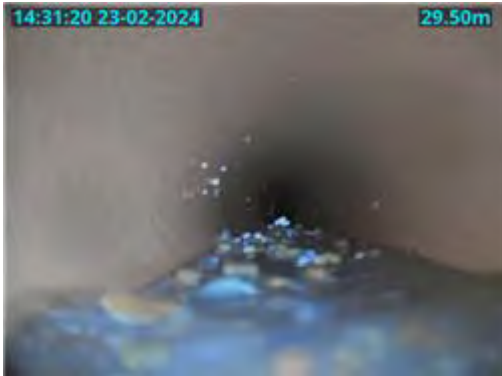
14.20m	0:01:21	R	Roots - Severity 3	
29.50m	0:02:28	DER	Settled deposits coarse: 30% Cross sectional area loss - Severity 3 Pea shingle	Image Provided - Ref: 13_9

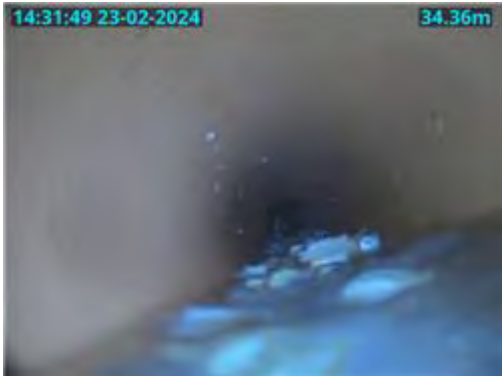
34.36m	0:02:58	DER	Settled deposits coarse: 30% Cross sectional area loss - Severity 3 Pea shingle	Image Provided - Ref: 13_10

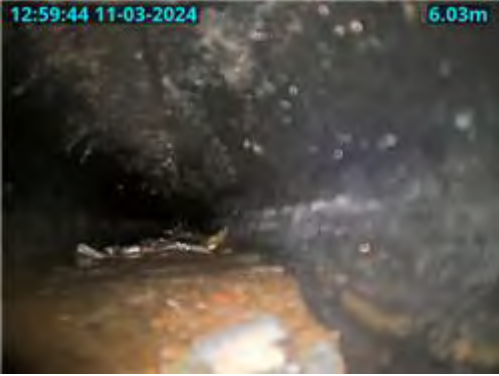
06.00m	0:00:39	S1 DES	Settled deposits fine 6m - 7.92m: 30% Cross sectional area loss - Severity 3	Image Provided - Ref: 18_3

07.92m	0:00:39	F1 DES	Settled deposits fine Defect End: 30% Cross sectional area loss - Severity 3

<p>Section: 19 From: SWMH1 To: Off Property</p> <p>MH</p>	<p>Recommendations</p> <p>CCTV monitored high pressure water jetting settled deposits removal.</p>	<p>DRB Grade: B Pipe Size: 100 Material: Pitch fibre Use: Surface Water</p>
