Drainage Report

London

PRO-DRAIN LTD

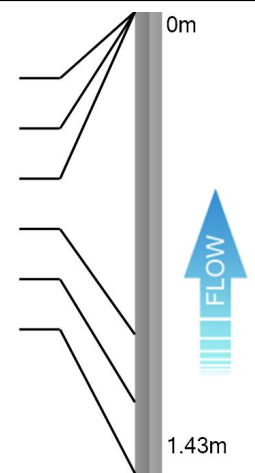
Position	Code	Description	CD	Pic	Video Ref
00.00m	MH	Start node type, manhole			
00.00m	WL	Water level 0%			0:00:00
00.00m	DEE	S1 Attached deposits, encrustation 12-12 10%	S1	2_2	0:00:06
01.00m	OJM	Open joint medium		2_3	0:00:10
01.21m	LUF	Line of drain/sewer deviates up [full]			0:00:19
01.43m	OCF	Finish node type, other special chamber

Pos	Video Ref	Code	Description	Image
00.00m		MH	Start node type, manhole MH1 Branch 1	
00.00m	0:00:00	WL	Water level: 0% Height/Diameter	
00.00m	0:00:06	S1 DEE	Attached deposits, encrustation 0m - 1m from 12 o'clock to 12 o'clock: 10% Cross sectional area loss - Severity 3	Image Provided - Ref: 2_2

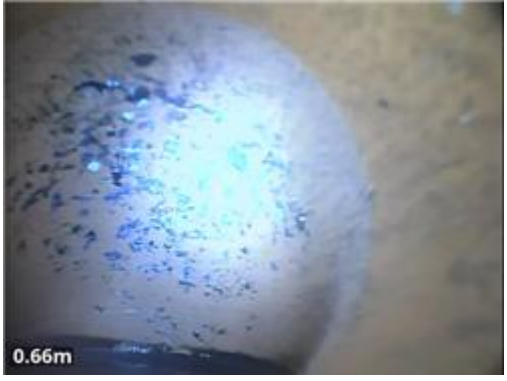
Section 4

Pos	Video Ref	Code	Description	Image
00.00m		MH	Start node type, manhole MH1 Branch 2	
00.00m	0:00:00	WL	Water level: 0% Height/Diameter	
00.77m		GYF	Finish node type Gully Gully 2	<p>Image Provided - Ref: 3_9999</p>

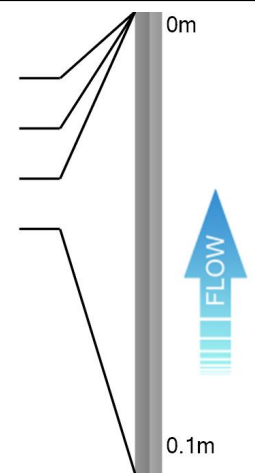
Position	Code	Description	CD	Pic	Video Ref
00.00m	MH	Start node type, manhole		4_0	
00.00m	WL	Water level 0%			0:00:00
00.00m	REM	General remark			0:00:11
00.10m	MHF	Finish node type, manhole

00.00m	0:00:00	WL	Water level: 0% Height/Diameter	
00.00m	0:00:11	REM	General remark There is no interceptor trap to stop rodent or odour infiltration into the private drainage system from the local authorities sewer	
00.10m		MHF	Finish node type, manhole MH1

<p>Section: 4 From: MH1 Branch 2 To: Gully 2</p>	<p>Recommendation</p> <p>N/A</p>	<p>DRB Grade: A Pipe Size: 100 Material: Polyvinyl Chloride Use: Combined</p>
<p>Section: 5 From: MH1 To: MH1</p>	<p>Recommendation</p> <p>Installation of a non return valve unit to prevent rodents and odours from the local authorities sewer</p>	<p>DRB Grade: A Pipe Size: 450 Material: Brick Use: Combined</p>
