Drainage Report

**East Lane Business Park
 Wembley**

**32 Westwood Park Industrial Estate
 Park Royal
 London
 W3 0TH**

32 Westwood Park - CCTV Survey Report : 19-03-24

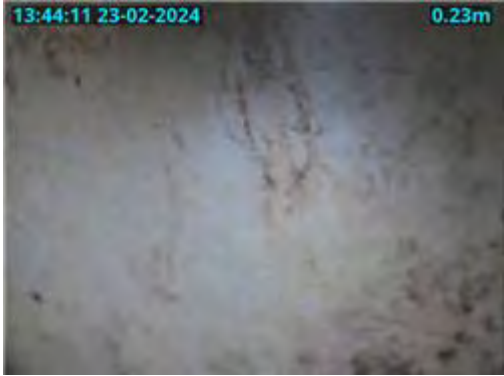
00.23m	0:00:05	LUF	Line of drain/sewer deviates up [full]	Image Provided - Ref: 1_2

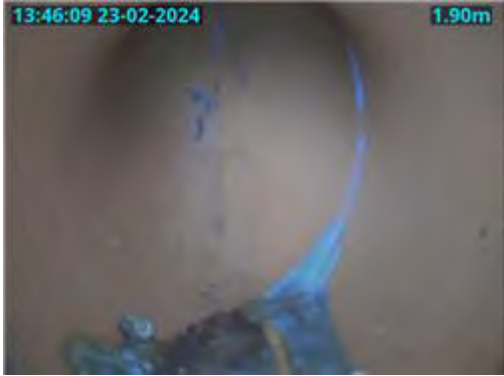
01.90m	0:00:23	LUF	Line of drain/sewer deviates up [full]	Image Provided - Ref: 2_3

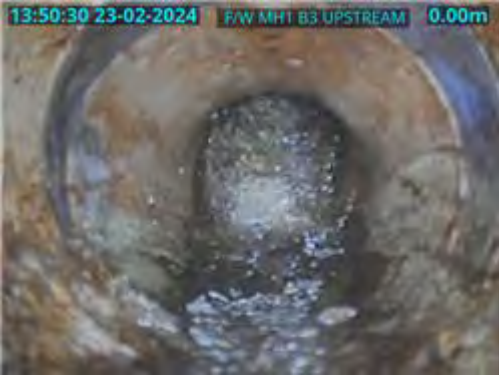
00.00m	0:00:00	DEE	Attached deposits, encrustation from 05 o'clock to 07 o'clock: 10% Cross sectional area loss - Severity 3 Scale build up	Image Provided - Ref: 3_2

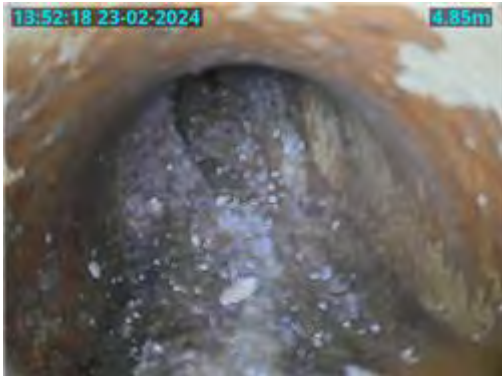
04.85m	0:00:47	LUF	Line of drain/sewer deviates up [full]	Image Provided - Ref: 4_5

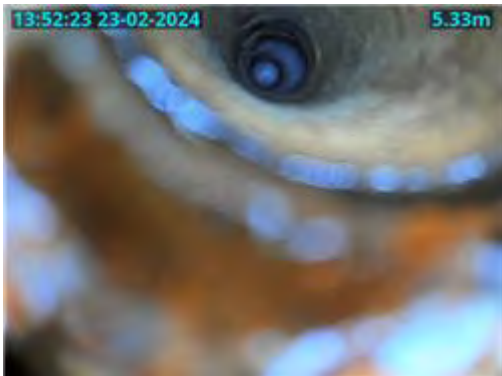
05.33m	0:00:10	F1 DEE	Attached deposits, encrustation Defect End from 03 o'clock to 09 o'clock: 50% Cross sectional area loss - Severity 3 Scale build up	
05.34m		OCF	Finish node type, other special chamber Urinal	Image Provided - Ref: 4_9999

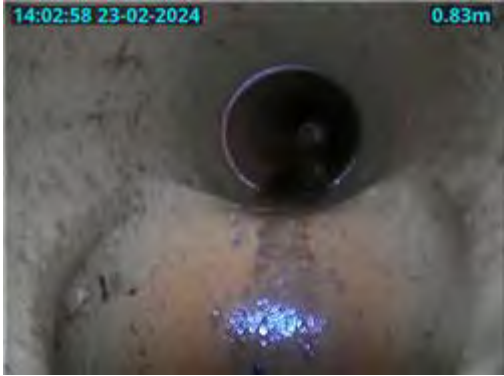
00.33m	0:00:25	REM	General remark Back Drop	Image Provided - Ref: 12_2

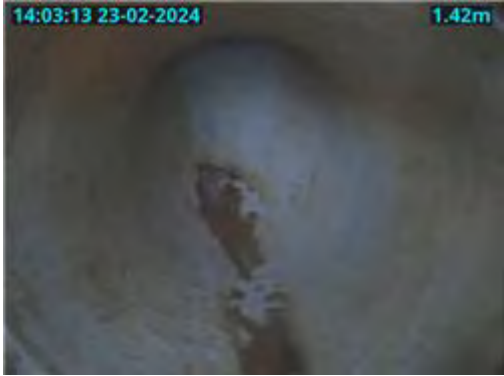
01.42m	0:00:51	LUF	Line of drain/sewer deviates up [full]	Image Provided - Ref: 12_3

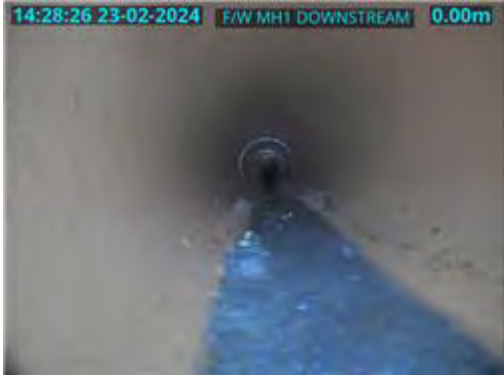
Pos	Video Ref	Code	Description	Image
00.00m		MH	Start node type, manhole FWMH1	
00.00m	0:00:00	WL	Water level: 0% Height/Diameter	Image Provided - Ref: 13_1

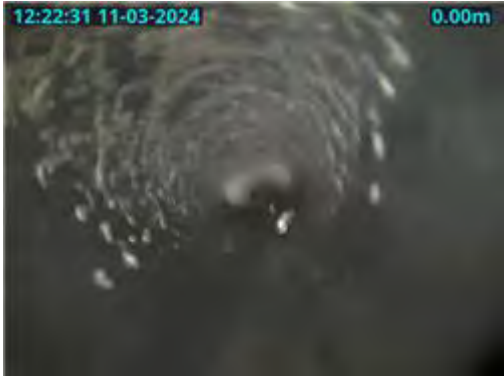
00.00m	0:00:00	LDF	Line of drain/sewer deviates down [full]	
00.10m	0:00:03	REM	General remark Rest Bend	Image Provided - Ref: 14_3

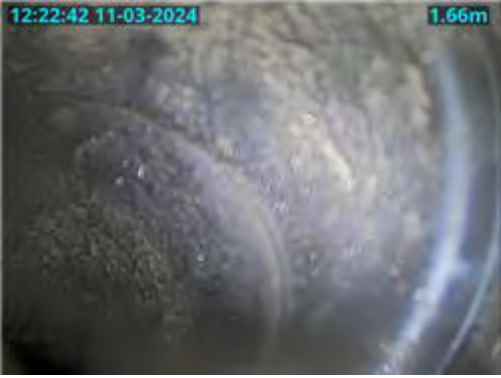
Pos	Video Ref	Code	Description	Image
01.66m	0:00:14	LLF	Line of drain/sewer deviates left [full]	Image Provided - Ref: 14_4

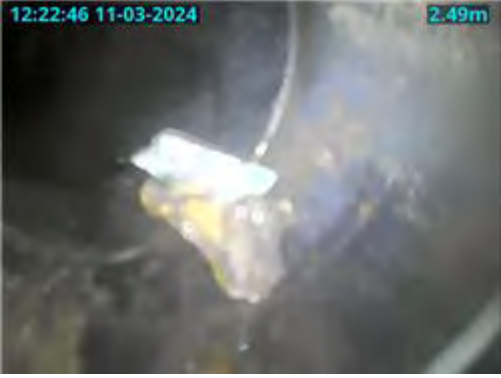
02.49m	0:00:18	LLF	Line of drain/sewer deviates left [full]	Image Provided - Ref: 14_5

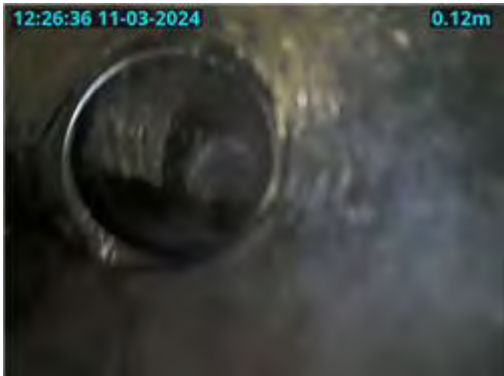
00.00m	0:00:00	LDF	Line of drain/sewer deviates down [full]	
00.00m	0:00:04	REM	General remark Rest Bend	Image Provided - Ref: 15_3

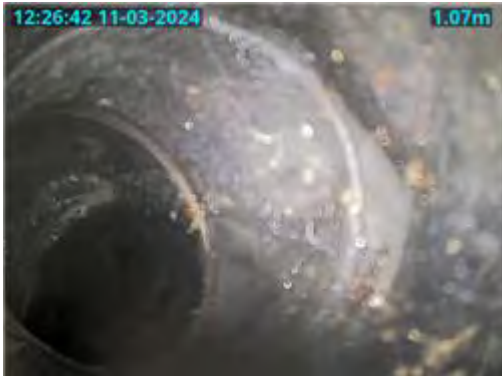
Pos	Video Ref	Code	Description	Image
01.07m	0:00:11	LLH	Line of drain/sewer deviates left [half]	Image Provided - Ref: 15_4

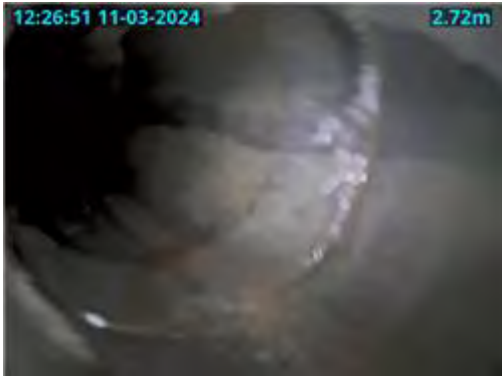
02.72m	0:00:19	LLH	Line of drain/sewer deviates left [half] Jct to main SW drain	Image Provided - Ref: 15_5

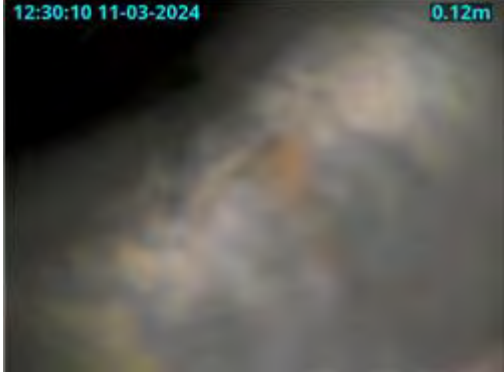
00.12m	0:00:04	REM	General remark Rest Bend	Image Provided - Ref: 16_2

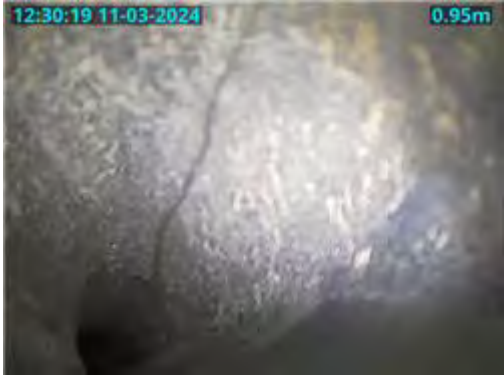
Pos	Video Ref	Code	Description	Image
00.95m	0:00:14	LLH	Line of drain/sewer deviates left [half]	Image Provided - Ref: 16_3

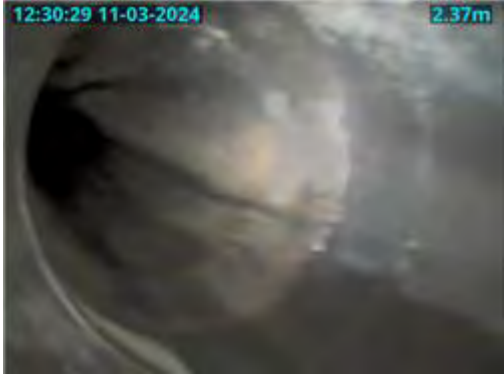
02.37m	0:00:23	LLH	Line of drain/sewer deviates left [half] Jct to main SW drain	Image Provided - Ref: 16_4

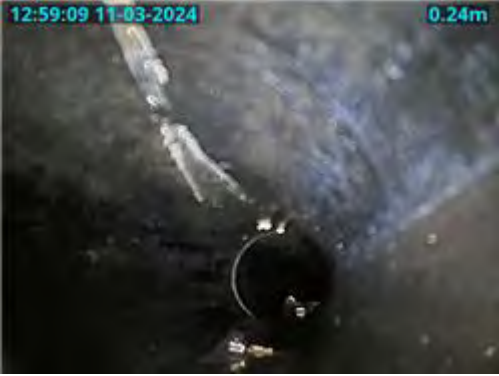
00.24m	0:00:04	LRQ	Line of drain/sewer deviates right [quarter]	Image Provided - Ref: 18_2
